## **Result of controlling drywood termites (*Cryptotermes domesticus* Haviland) using a novel method**

Trinh Van Hanh<sup>1</sup>, Tran Thi Thu Huyen,  
Do Tien Manh, Nguyen Thuy Hien  
Institute of Ecology and Works protection

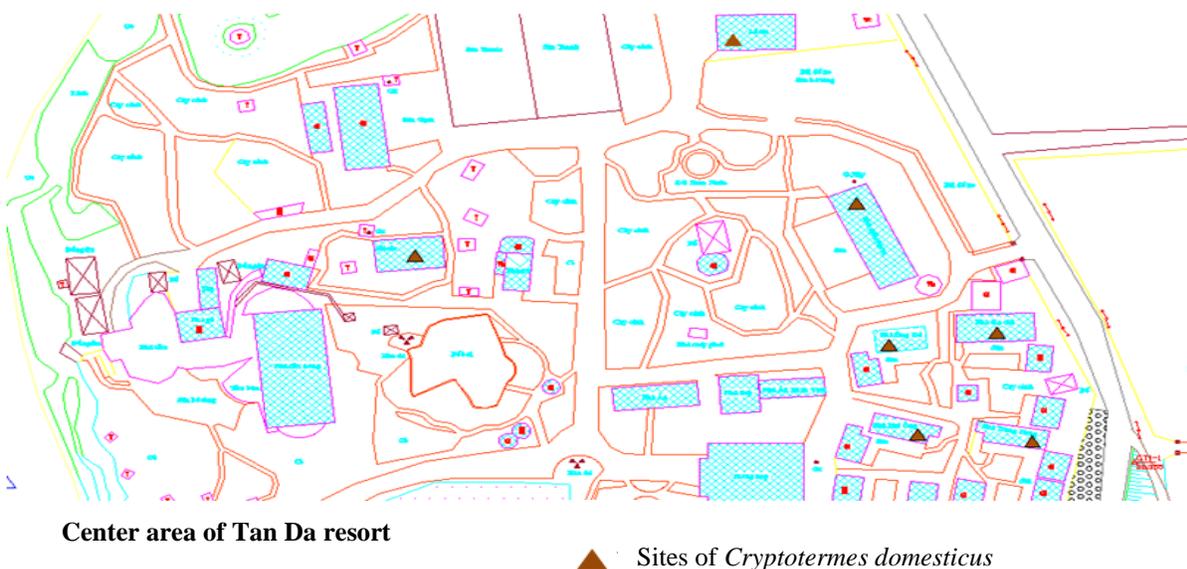
**Figure 1. Position of dry wood termite damaging in the Central area of Tan Da Resort**

A total of 42 structural and decorative items were investigated at the Tan Da Resort and 27 were damaged by drywood termites. The damaged items were focused mainly in the Central area of the Resort, including the House on stilts, ancient houses and working room (figure 1). At the affected areas, we realized that drywood termite caused damage at 3 main locations within buildings namely the wooden dividing walls in rooms of the ancient houses, wooden pillars and collar beams of the houses on stilts, and the reception house and management house.

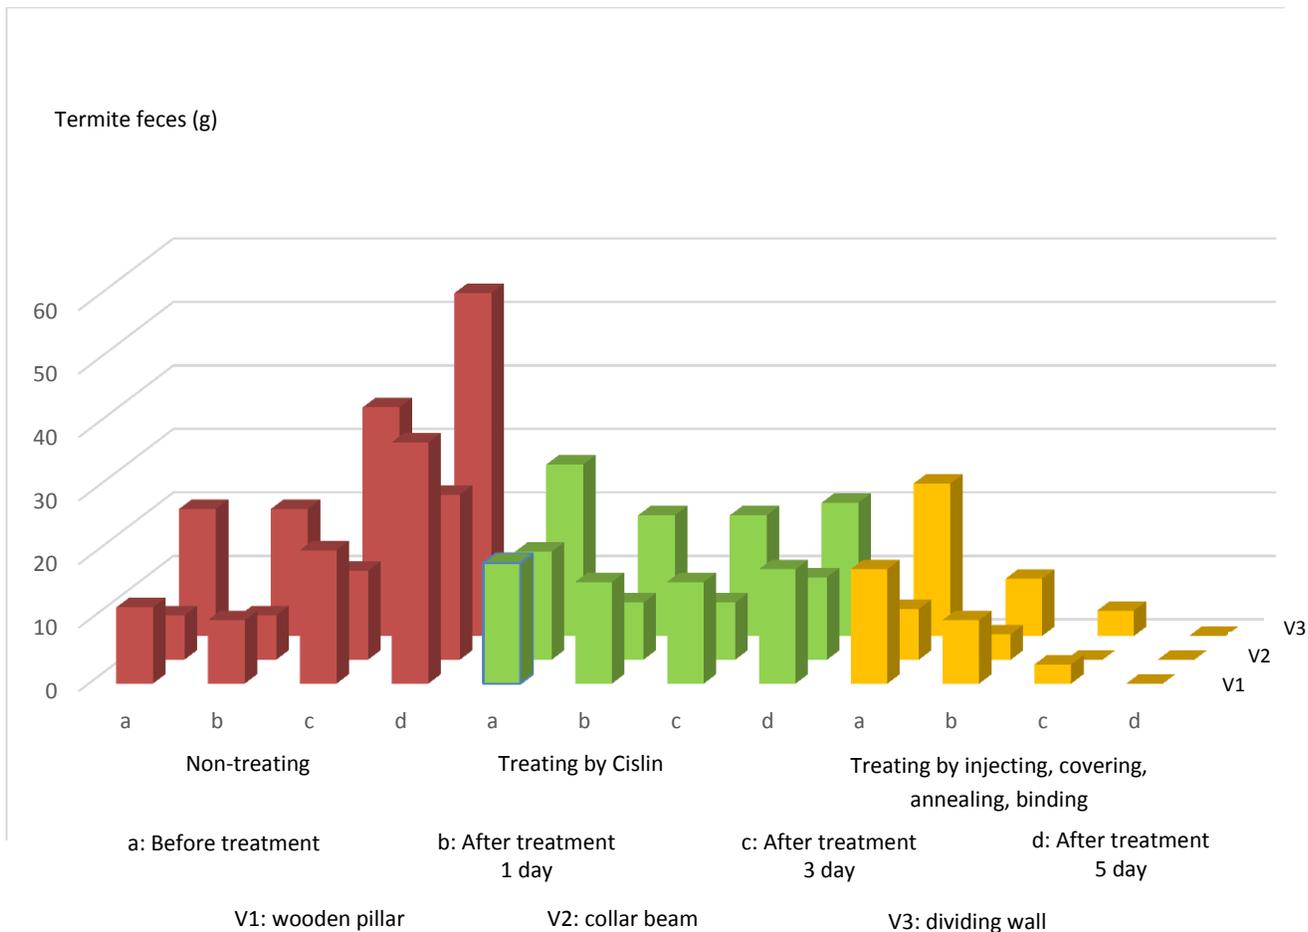
**Figure 2. Quantity of termite feces at treatment positions according to the time**

The results in Figure 2 shows that at the time of treatment, the quantity of drywood termite feces discharged at the wooden dividing wall was more than that in 2 other groups in that structure. The quantity of termite feces was the least from the collar beam group at before and after treatment. One day after treatment, the quantity of termite feces at all treatment positions decreased (decreased on average 8.6g/structural element in comparison to before testing). The quantity of termite feces continued to decrease (on average 14 g/structural element) after 3 days of treatment. Five days after treatment, there were no feces of drywood termite at treatment points. Meanwhile, in comparison, the quantity of feces was slightly reduced but increased gradually after testing. For the measure on injecting Cislin through the knock-out holes, the quantity of discharged feces was reduced in comparison to the periods 1 and 3 days before testing on average, 6.3 g/structural element after treatment. The efficiency of injecting Cislin against the drywood termite was 17.5% after 5 days which indicated that the colony was reduced but not eliminated (Figure 3). Meanwhile the injecting covering, and, binding treatment achieved 100% efficiency after 5 days.

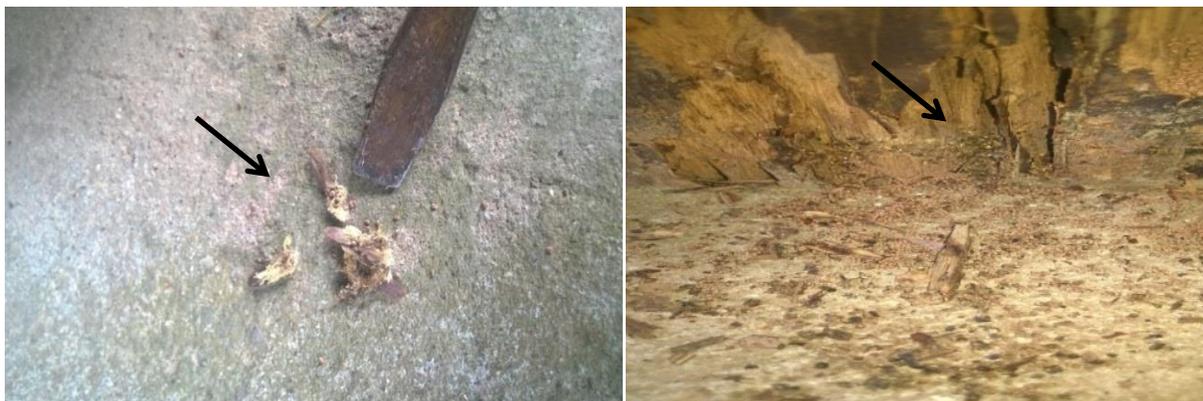
**Figure 3. Wing termite and head of worker termite died  
at position of wooden pillar at house on stilts of Tan Da Resort**
